3. Subbasin Assessment – Pollutant Source Inventory

3.1 Sources of Pollutants of Concern

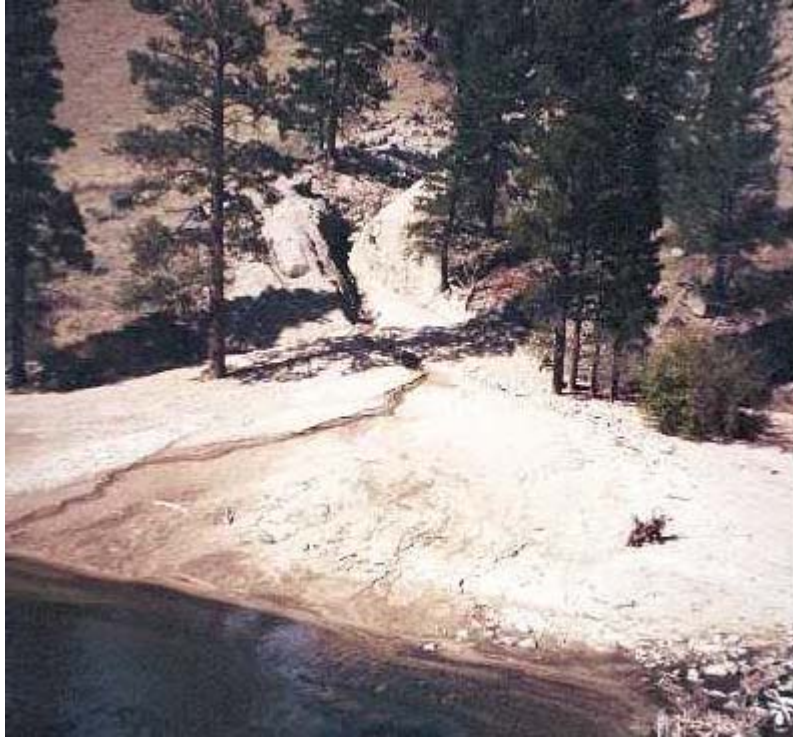
Figure 42. Jack Creek blowout – Middle Fork Salmon River, September 17, 2002

The debris at Jack Creek came from the west side just upstream of Loon Creek from an upland type slope dotted with some sagebrush and grasses and forbs.

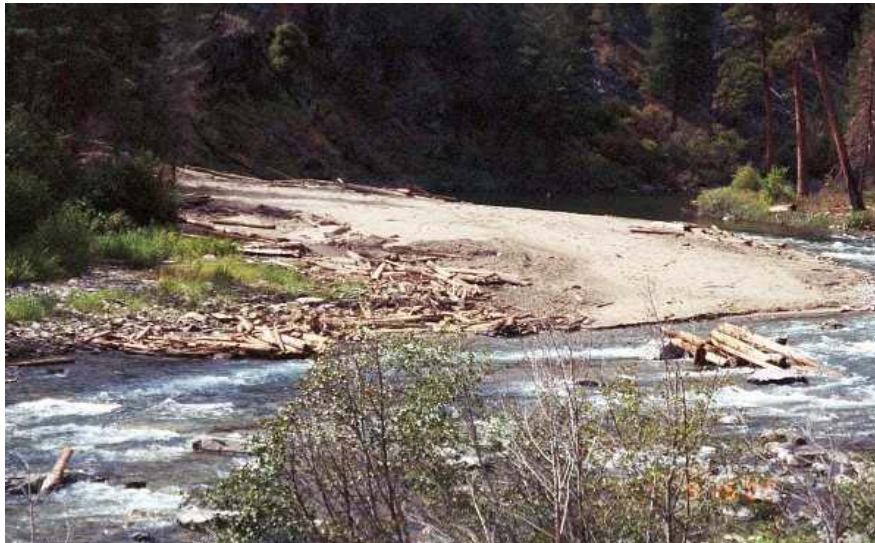
Figure 43. Orelano Creek blowout – Middle Fork Salmon River, September 2002

Orelano Creek is a relatively small drainage, very steep, heavily forested.
